**SUBJ:** Fuselage – Cracking at Aft Tail Post Weld Joint on Piper Model PA-18 (L-21) Airplanes      **SAIB:** CE-13-14  
**Date:** February 6, 2013

This Special Airworthiness Information Bulletin (SAIB) alerts you, owners and operators of certain **Piper Aircraft, Inc. Model PA-18 (L-21)** airplanes, of cracking discovered in the weld joint of the aft fuselage tail post. This SAIB also provides guidance on recommended inspections for various Piper airplane models with similar tail post configurations.

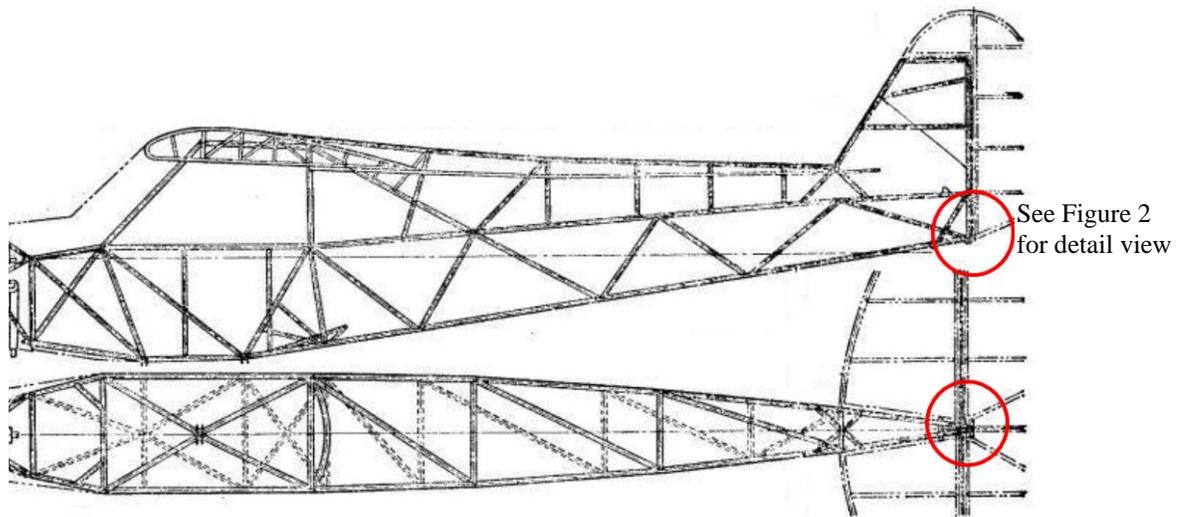
Additional airplanes from the operator were inspected and a total of three out of five airplanes showed cracking at the same location. The lowest time airplane with cracking had accumulated approximately 4,000 hours total time-in-service (TIS). The highest time airplane without cracking had accumulated over 6,500 hours TIS. The x-ray inspections were also used to check for corrosion of the tubes and welds that could contribute to the problem. Only minor internal corrosion was visible on any of the inspected airplanes.

If undetected, these conditions could eventually lead to significant cracking and / or corrosion of the fuselage tube structure and result in a potential safety of flight hazard such as loss of control of the lower rudder hinge or tail wheel.

Figure 1 – Aircraft-level view of damage area

The FAA recommends the Piper airplane models listed below that have accumulated 1,000 hours total TIS be inspected within the next 100 hours TIS in the fuselage tail post area. We recommend use of an inspection method such as fluorescent penetrant and / or x-ray. Additionally, we recommend repeating the inspection every 1,000 hours TIS. These inspections are particularly important if the aircraft is subject to operation in severe turbulence, towing, or on rough terrain.

Repair or replace damaged components if you find cracks or corrosion

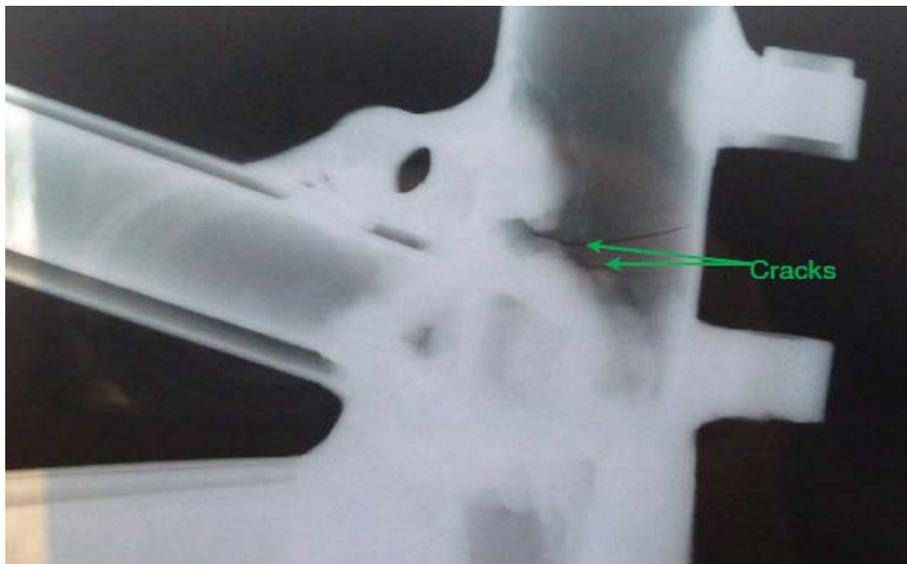
We received notice of this issue from a foreign operator. A Piper Model L-21B (PA18-135) airplane fuselage was completely disassembled to replace the worn fabric fuselage covering. After removing the fabric covering, paint was removed from the fuselage frame in areas considered susceptible to high stress and at major weld joints. A fluorescent penetrant inspection (FPI) was done on all these areas. The FPI inspection revealed two cracks in the fuselage tail section protruding into the lower rudder attachment hinge area (see Figure 1). To determine the extent of cracks into the adjacent welds and tubing, additional x-ray inspection of the area was done. The x-ray inspection revealed that the cracks did protrude into the adjacent weld areas (see Figure 2).

Figure 2 – Detail view of tail joint damage area
